RANGE HOODS / ISLANDS

RAINBOW - ISLAND

24539-S • (36" - 860 CFM)

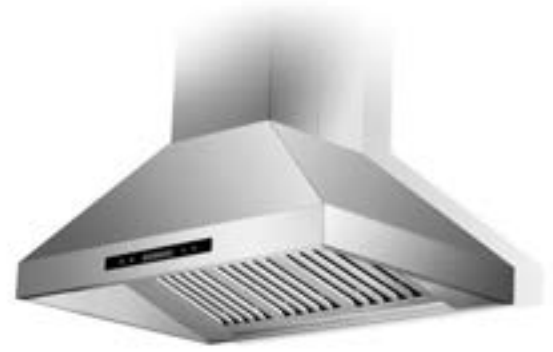
DIMENSIONS

- Stainless steel finish
- 860 CFM
- Noise level: low speed 0.7 to hi 9.0 sones (high speed)
- 3-speed electronic dual control panels, LCD (front)
- Remote control
- 2 LED bulbs, 5W, with 2 light levels (incl.)
- Stainless steel baffle filters (incl.)
- 6" round vertical vent exhaust
- Telescopic chimney 10" (bottom section) - 10" (top section)
- Good for ceilings of 8 ft
- Chimney extension available for ceiling heights of up to 9 ft - 15" (bottom section) - 15" (top section)
