# RANGE HOODS / WALL-MOUNT

## RAINBOW

24530-480-BK • (30" - 480 CFM)

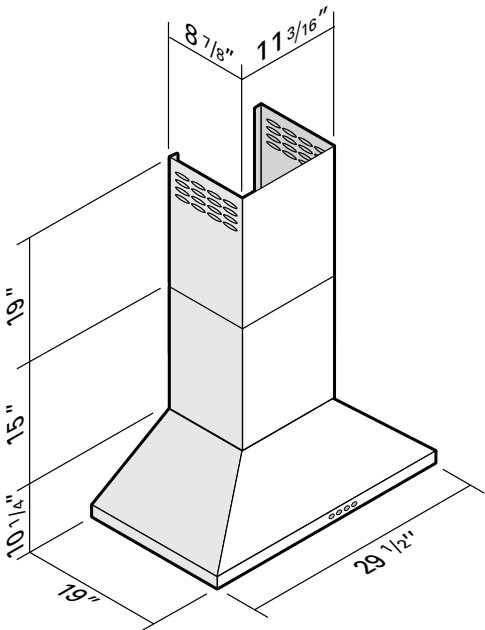
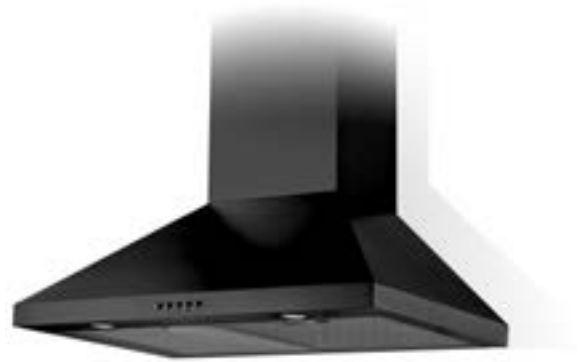
### DIMENSIONS

- Black finish
- 480 CFM
- Noise level: low speed 0.6 to hi 8.0 sones (high speed)
- 3-speed control
- 2 LED bulbs, 5W, with 2 light levels (incl.)
- 5-layer aluminum filters (incl.)
- 6" round vertical vent exhaust
- Telescopic chimney 15" (bottom section) - 19" (top section)
- Optional 30" chimney for ceilings up to 10 feet
- Good for ceilings up to 9 ft.
