RANGE HOODS / WALL-MOUNT

LUNA-CRISTAL

24600-480-S • (30" - 480 CFM)

TECHNICAL SPECIFICATIONS

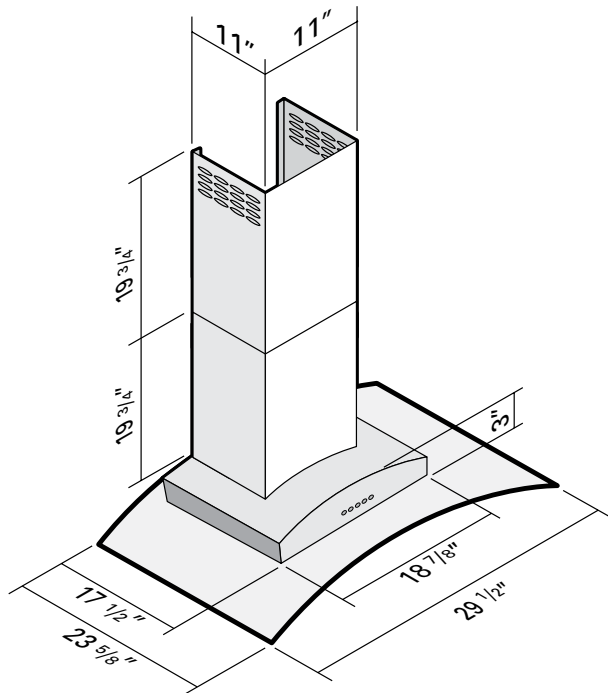
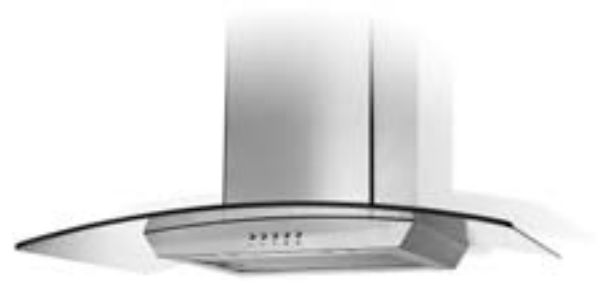
DIMENSIONS

- Tempered glass and stainless steel finish
- 480 CFM
- Noise level: low speed 0.6 to hi 8.0 sones (high speed)
- 3-speed control
- 2 LED bulbs, 5W, with 2 light levels (incl.)
- 5-layer aluminum filters (incl.)
- 6" round vertical vent exhaust
- Telescopic chimney 19 3/4" (bottom section) - 19 3/4" (top section)
- Optional 30" chimney for ceilings up to 10 feet
- Good for ceilings up to 8 ft 6 in. (For 9' (108") ceilings, the hood can be installed using the sections of chimney provided, as long as it is installed at a distance of at least 31" from the counter.)
