RANGE HOODS / WALL-MOUNT

SLIM

24900-480-S • (30" - 480 CFM)

24900-390-S • (30" - 390 CFM)

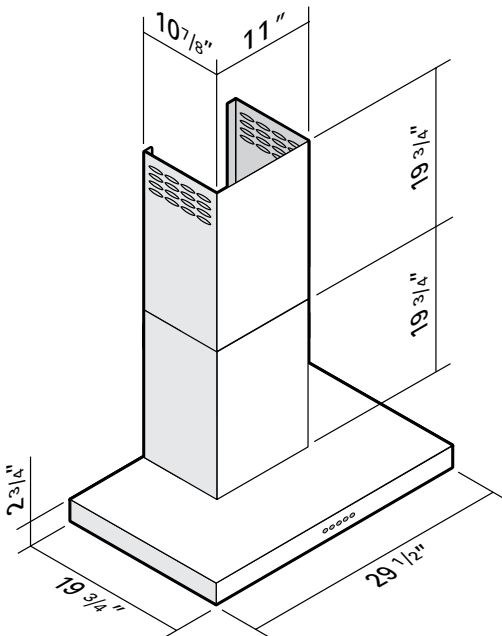
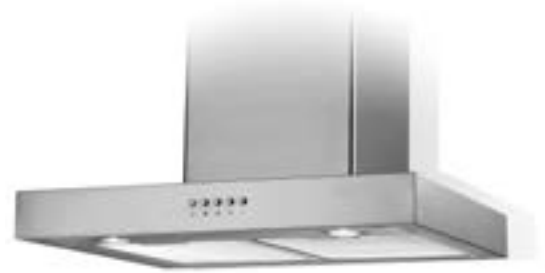
DIMENSIONS

- Stainless steel finish
- 390 and 480 CFM
- Noise level: low speed 0.6 to hi 8.0 sones (high speed)
- 3-speed control
- 2 LED bulbs, 5W, with 2 light levels (incl.)
- 5-layer aluminum filters (incl.)
- 6" round vertical vent exhaust
- Telescopic chimney
19 3/4" (bottom section) -
19 3/4" (top section)
- Optional 30" chimney for ceilings up to 10 feet
- Good for ceilings up to 8 ft 6 in. (For 9' (108") ceilings, the hood can be installed using the sections of chimney provided, as long as it is installed at a distance of at least 31" from the counter.)
