RANGE HOODS / ISLANDS

SLIM - ISLAND

24936-860-S • (36" - 860 CFM)

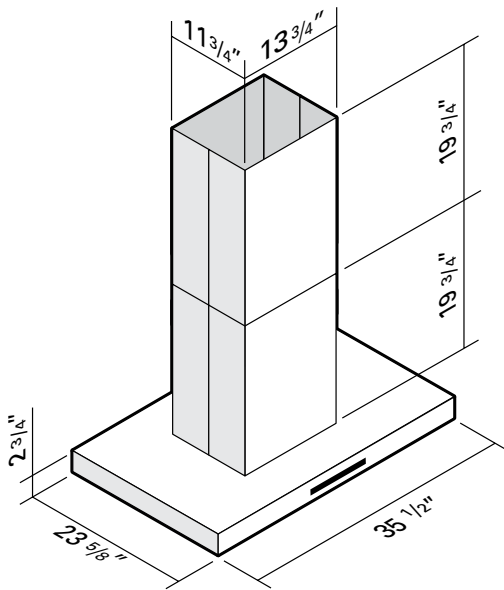
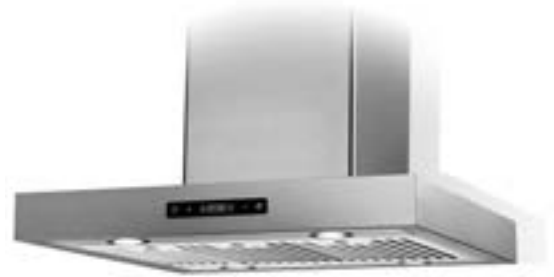
DIMENSIONS

- Stainless steel finish
- 860 CFM
- Noise level: low speed 0.7 to hi 9.0 sones (high speed)
- 3-speed electronic control panel, LCD with clock
- Remote control
- 4 LED bulbs, 5W, with 2 light levels (incl.)
- Stainless steel baffle filters (incl.)
- 6" round vertical vent exhaust
- Telescopic chimney 19 3/4" (bottom section) - 19 3/4" (top section)
- 35" chimney in option
- Good for ceilings up to 8 ft 6 in. (For 9' (108") ceilings, the hood can be installed using the sections of chimney provided, as long as it is installed at a distance of at least 31" from the counter.)
